ARCHAEOLOGICAL DESK-BASED ASSESSMENT

Manor Farm, Poyle Road, Slough, Berks

Project Code: 794-PLN-HER-00628
Manor Farm, Poyle Road, Slough
Final
12 December 2024
NGR: TQ 02943 76060
Local Planning Authority:
Slough Borough Council

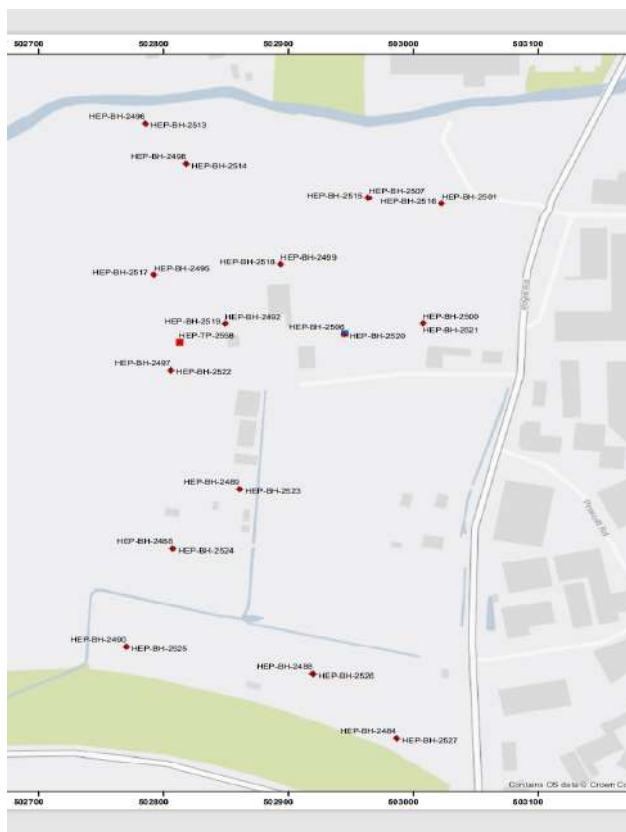
- 3.5 An extract of a Heathrow Airport expansion related Ground Investigation report by Fugro (2019), below, provides a location plan of Ground Investigation boreholes that took place within and west of the sites;

- 3.6 The associated borehole logs (see Appendix D) illustrate the depth of made ground at the Battery Storage site as follows:
- HEP-BH-2525 (western extent of Battery Storage proposal site) – 0.3m topsoil above 4.7m of Made Ground;

- HEP-BH-2526 (central area of Battery Storage proposal site) – 0.1m topsoil over 4.1m of Made Ground; and
 - HEP-BH-2527 (south-eastern extent of Battery Storage proposal site) - 0.2m topsoil over 4.0m of Made Ground.

- 3.9 It therefore appears most of the Data Centre site has been subject to quarrying ahead of landfill. The possible exception is the north-east grassed zone where there are no boreholes to corroborate and areas close to existing Manor Farm buildings at the south-east extent of the site whose presence means landfill did not extend that far east.

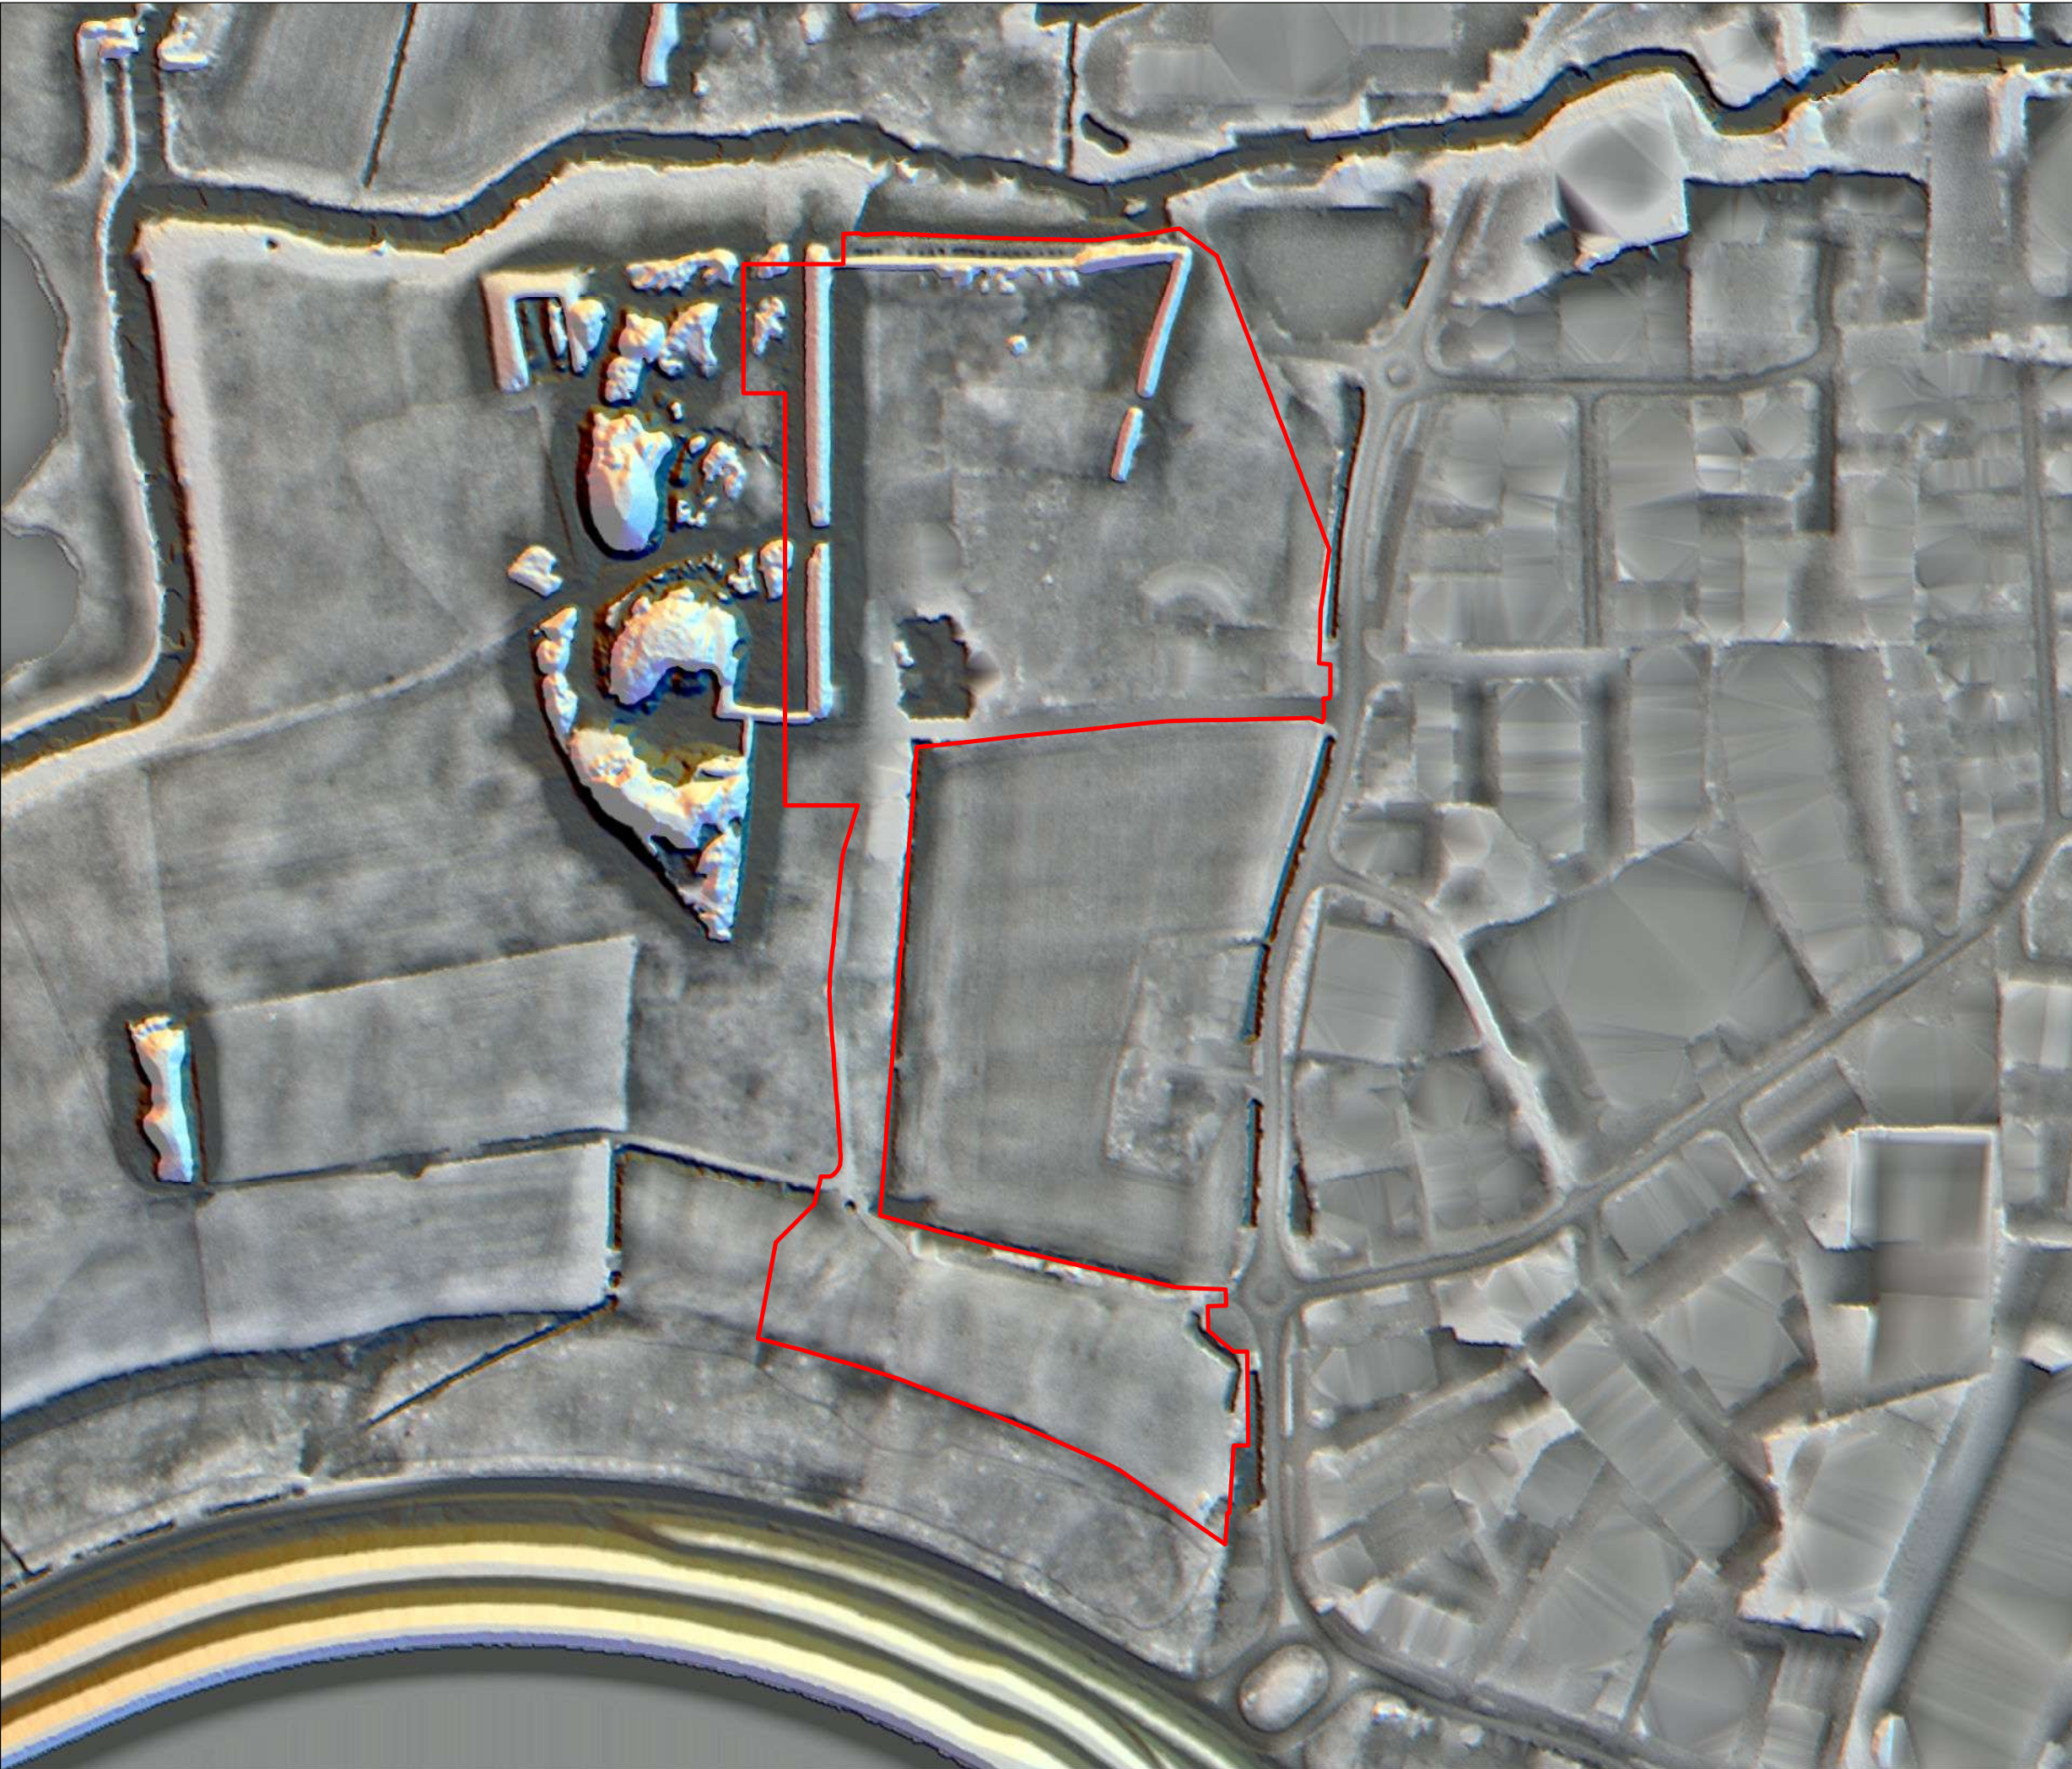
Figure 3

LiDAR survey

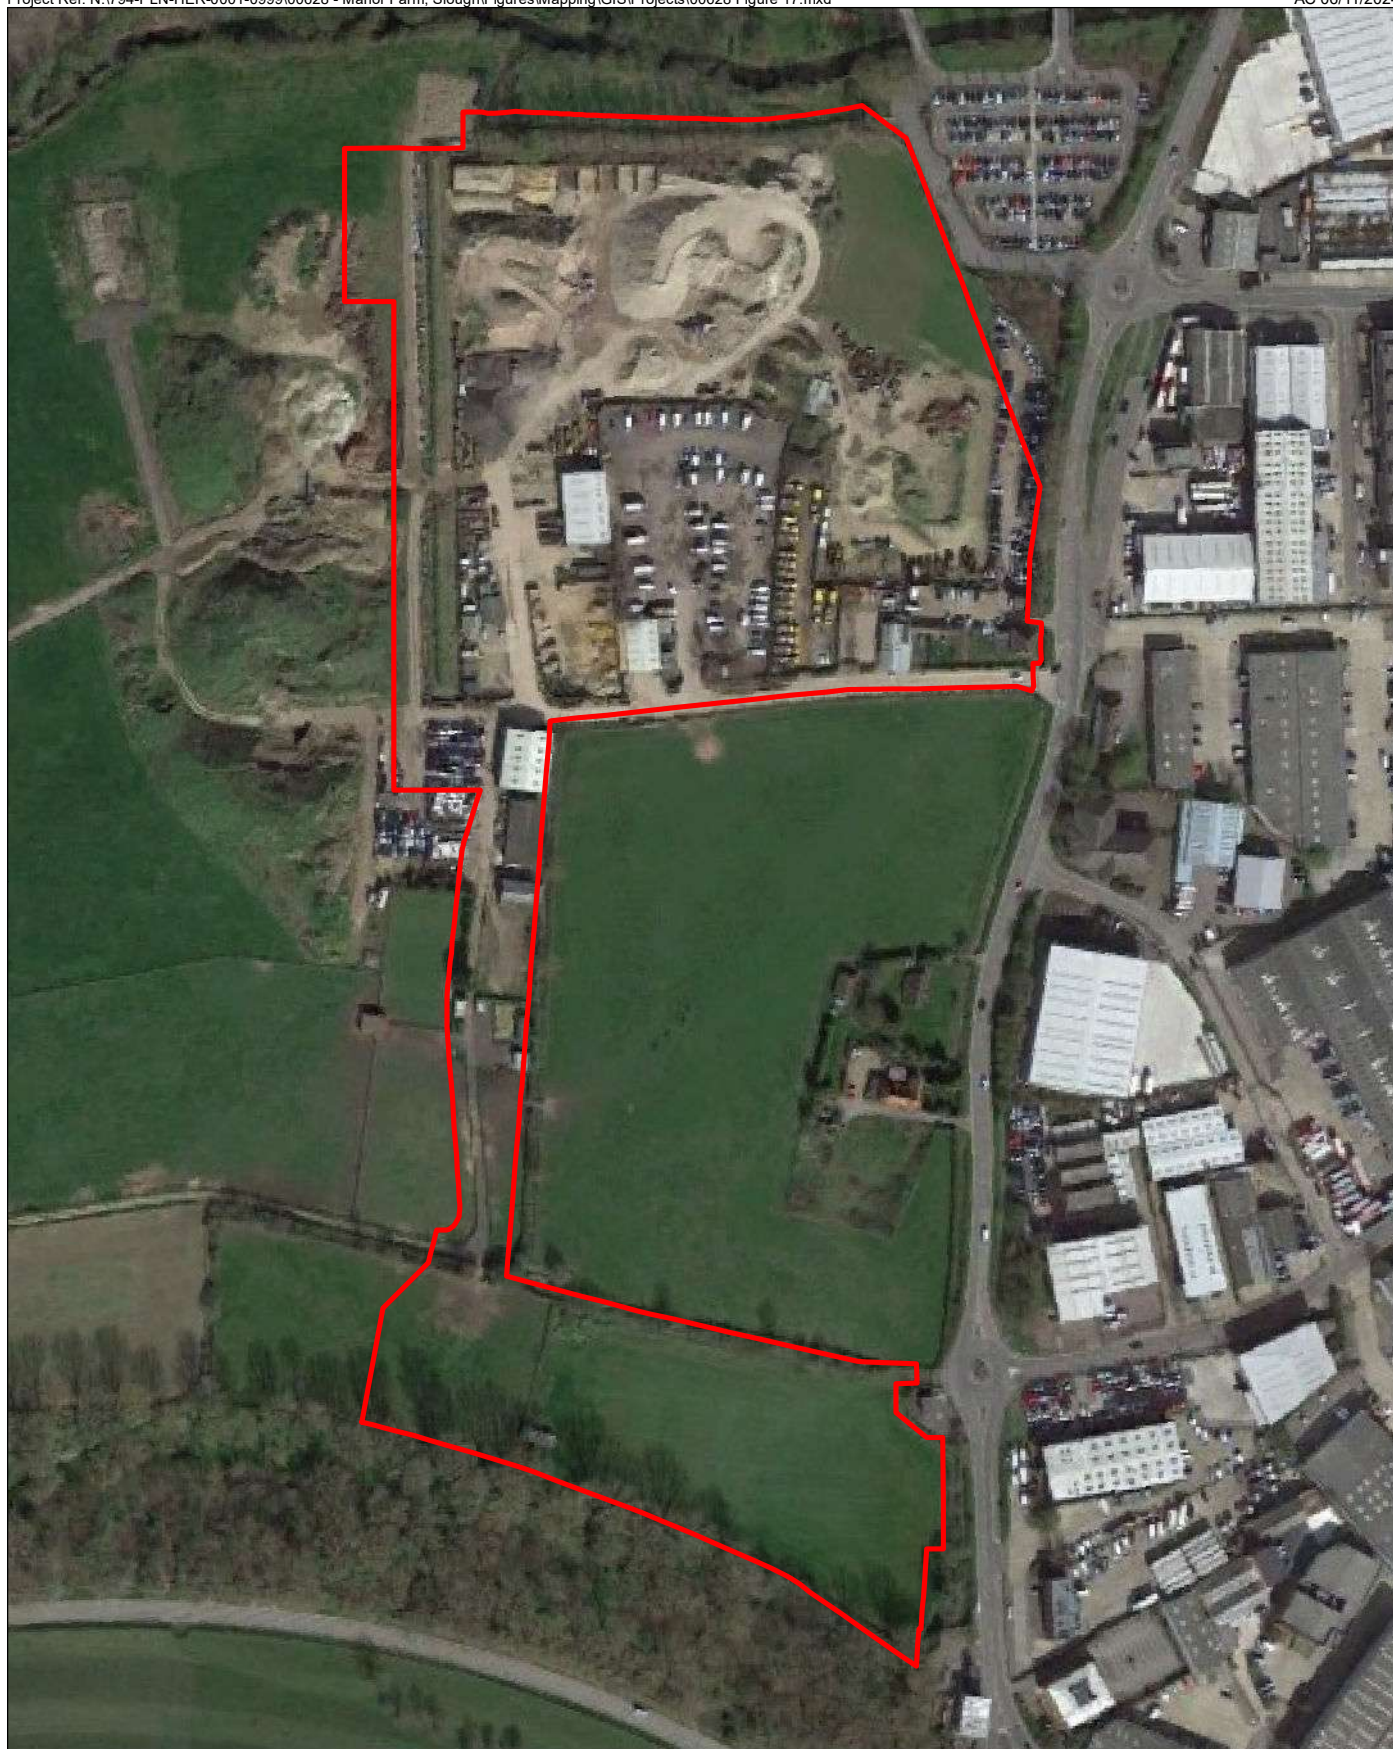
Figure 16

1984 to 1987 1:10,000 scale
Ordnance Survey Map

- 4.110 There are no major changes to the sites 1984 to 1987 on the 1:10,000 scale Ordnance Survey Map (Fig. 16) but the M25 had by now been constructed to the east. The 1980's map does not show quarrying or landfill.

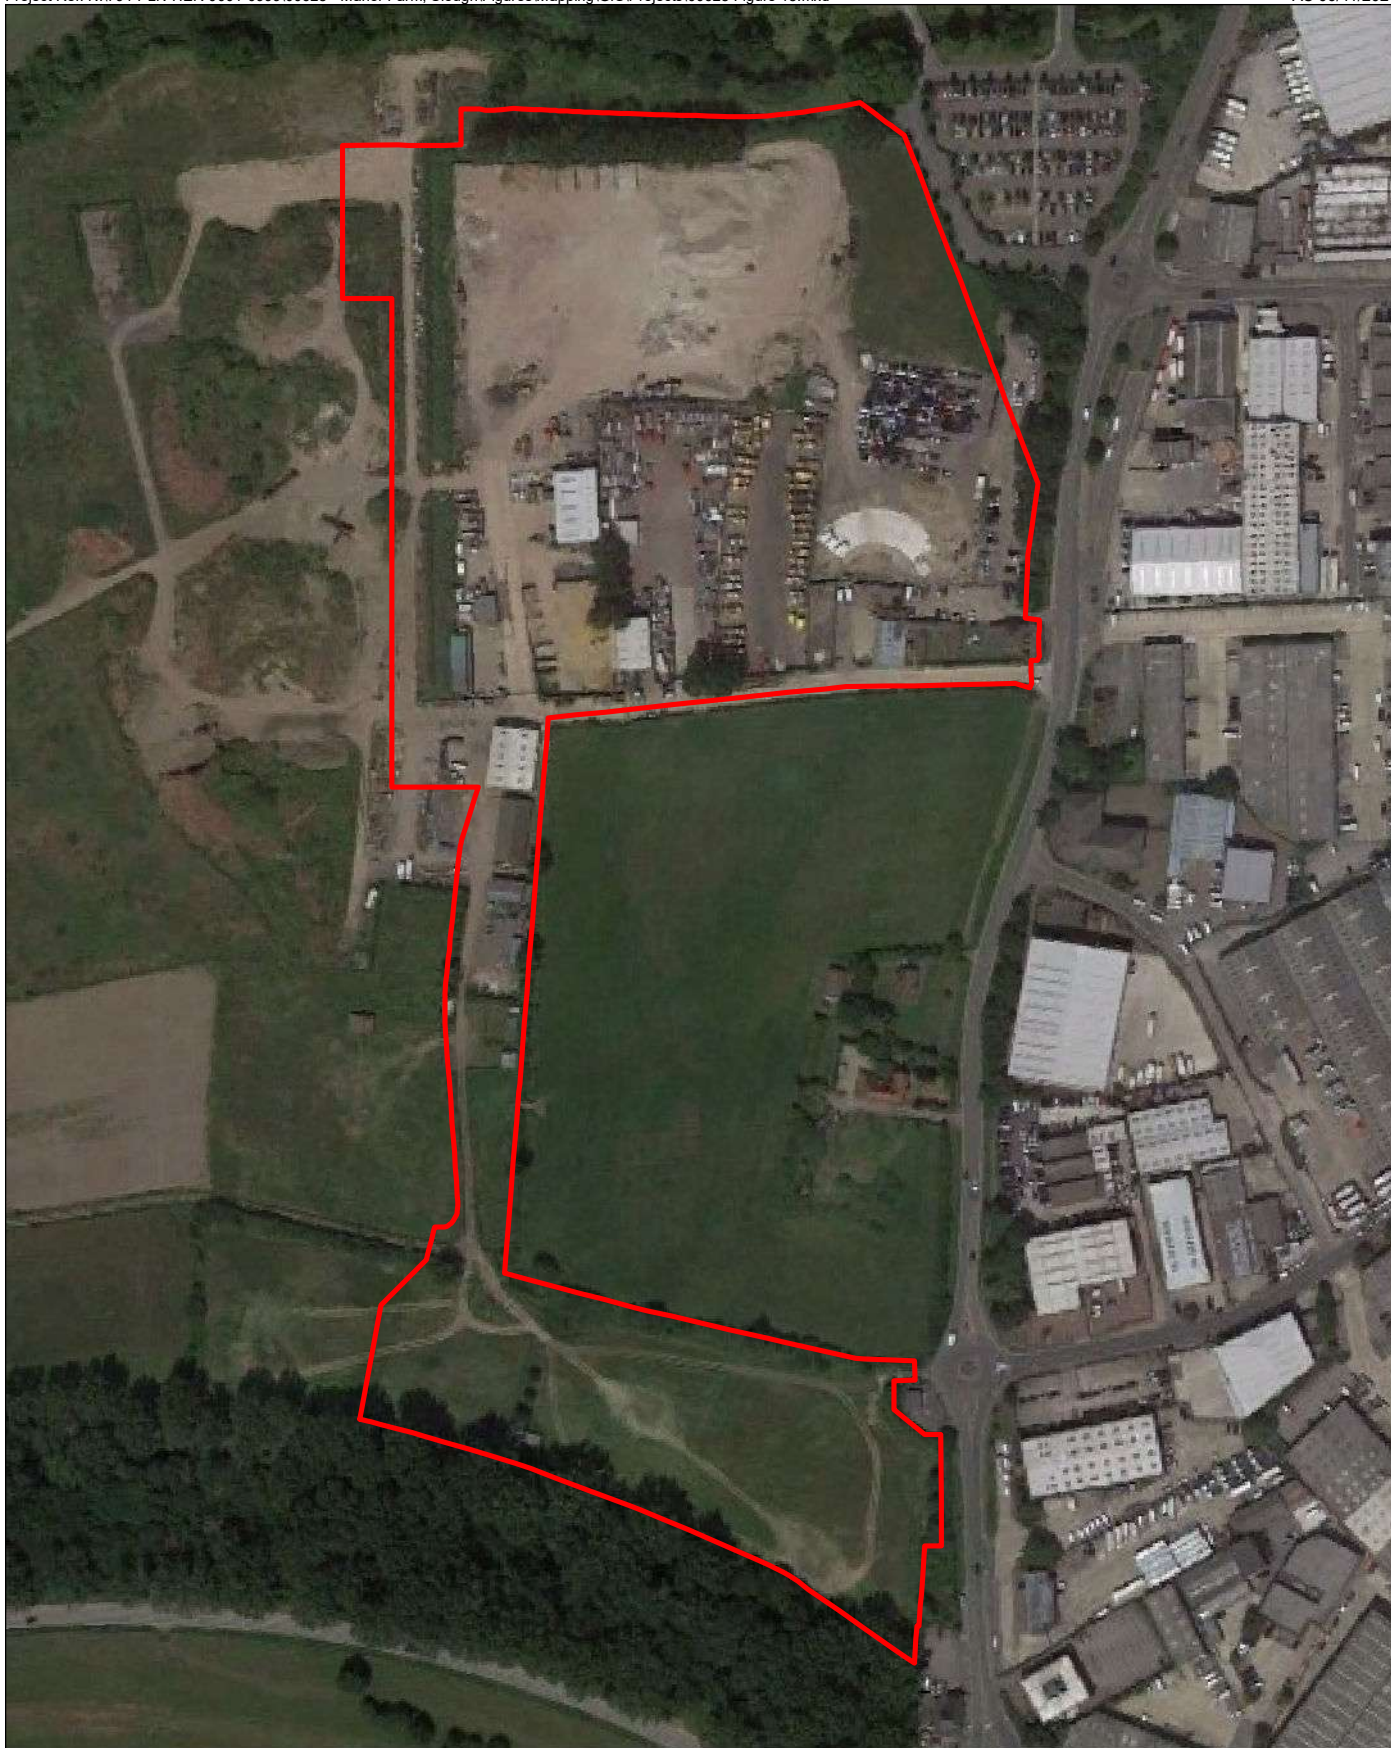
Figure 17

2017 Google Earth aerial image

- 4.111 The 2001 1:10,000 scale Ordnance Survey Map (Fig. 16) simply labels 'Gravel Pit' to the west side of the Data Centre site.
- 4.112 The 2017 Google Earth aerial image (Fig. 17) shows the central southern area of the Data Centre site now surfaced for car parking. Large stockpiles and haul routes for gravel storage are visible within the north-west and parts of the south-east area of the Data Centre site, as well as mounds of gravel to the immediate west. It is not clear whether the material was stored over exiting hardstandings or on soft ground. If the latter these zones may have suffered truncation form rutting (whether extraction had first occurred within this area is not clear). The grassed area in the north-east zone of the Data Centre site is intact.

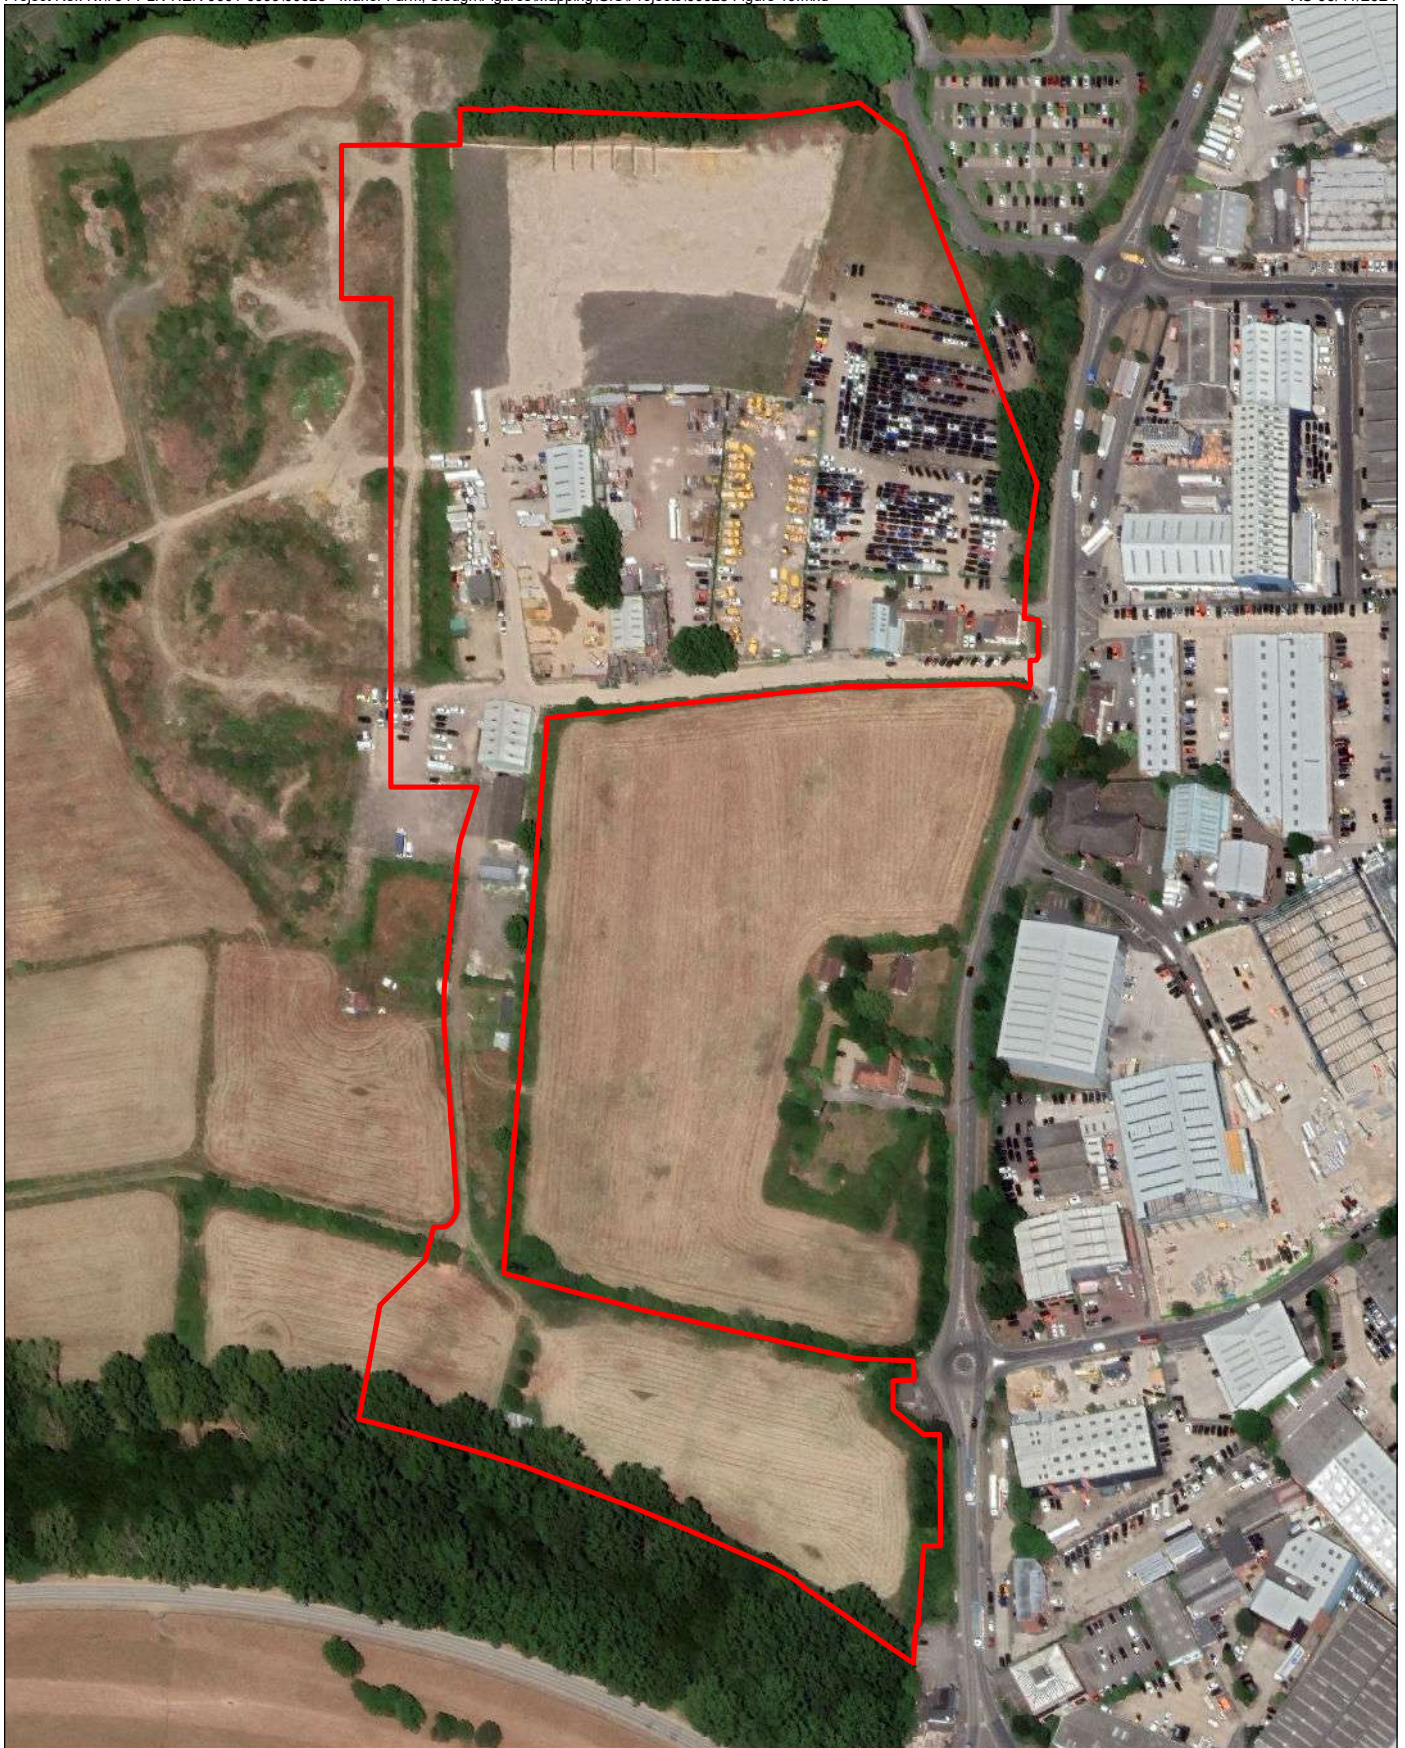
Figure 18

2019 Google Earth aerial image

- 4.113 That the areas were soft landscape appears to be confirmed by the 2019 Google Earth aerial image (Fig. 18) which shows that most of the bunds and been removed exposing bare earth ground. The south-eastern area of 2017 disturbance is now shown as car park. The light industrial buildings on the site are also shown.

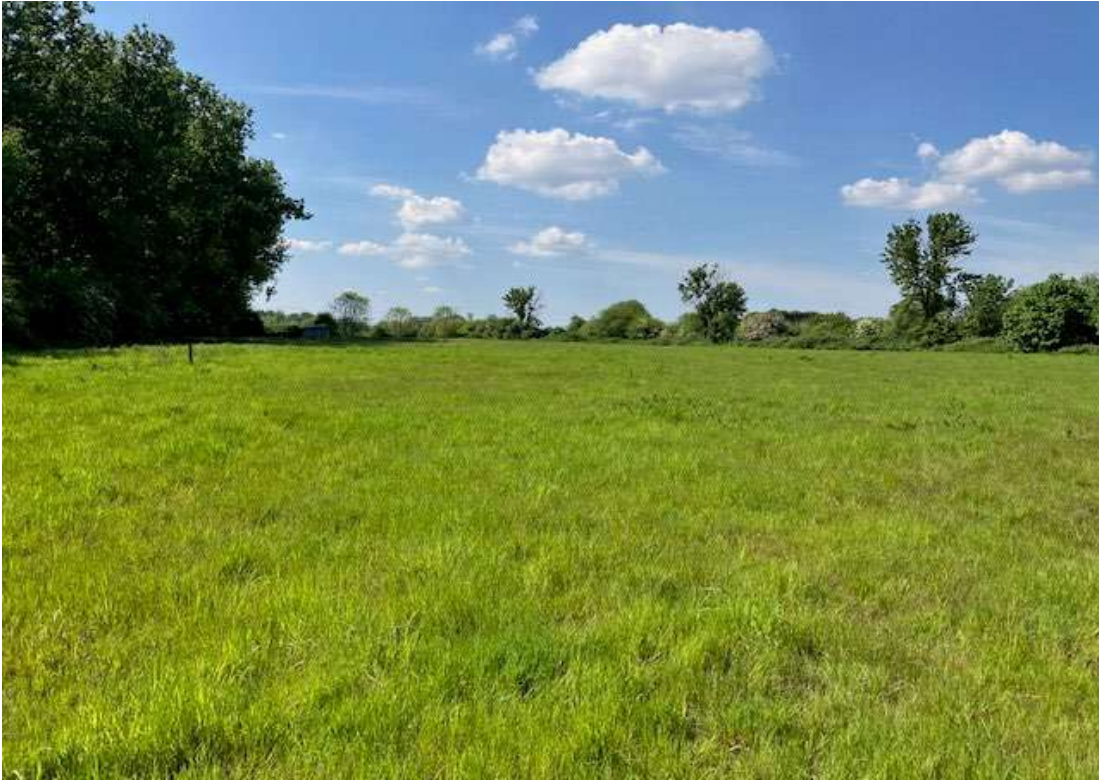
Plate 1: Battery Storage Site Eastern Field (looking West)

- 5.1 A site visit was conducted on 9th May 2024 (Plates 1-12). The conditions were bright and dry. The southern Battery Storage (BESS) site currently comprises pastureland within two fields south of Poyle Farm. The ground is uneven perhaps reflecting the Made Ground deposition. There is a mature hedge with trees forming the northern boundary (see Plates 1 and 2).

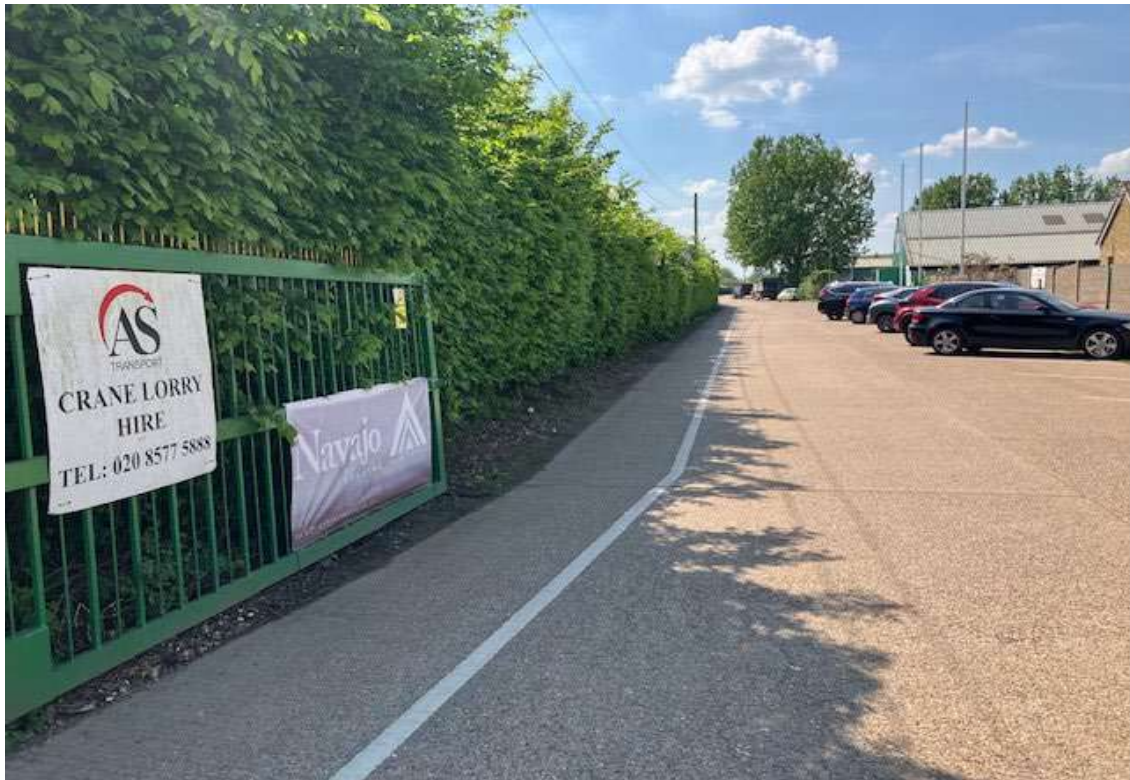
Plate 3: Manor Farm - Data Centre Site (southern extent looking West from south-east corner)

- 5.2 The Data Centre site comprises an access road along its south edge with various light industrial use buildings fronting it (along with the 20th century Manor Farm buildings at the connection with Poyle Road) (see Plates 3, 4, 11 and 12). There are a series of surfaced compounds within the interior that include zones used for vehicle storage buildings (Plates 7 to 9).

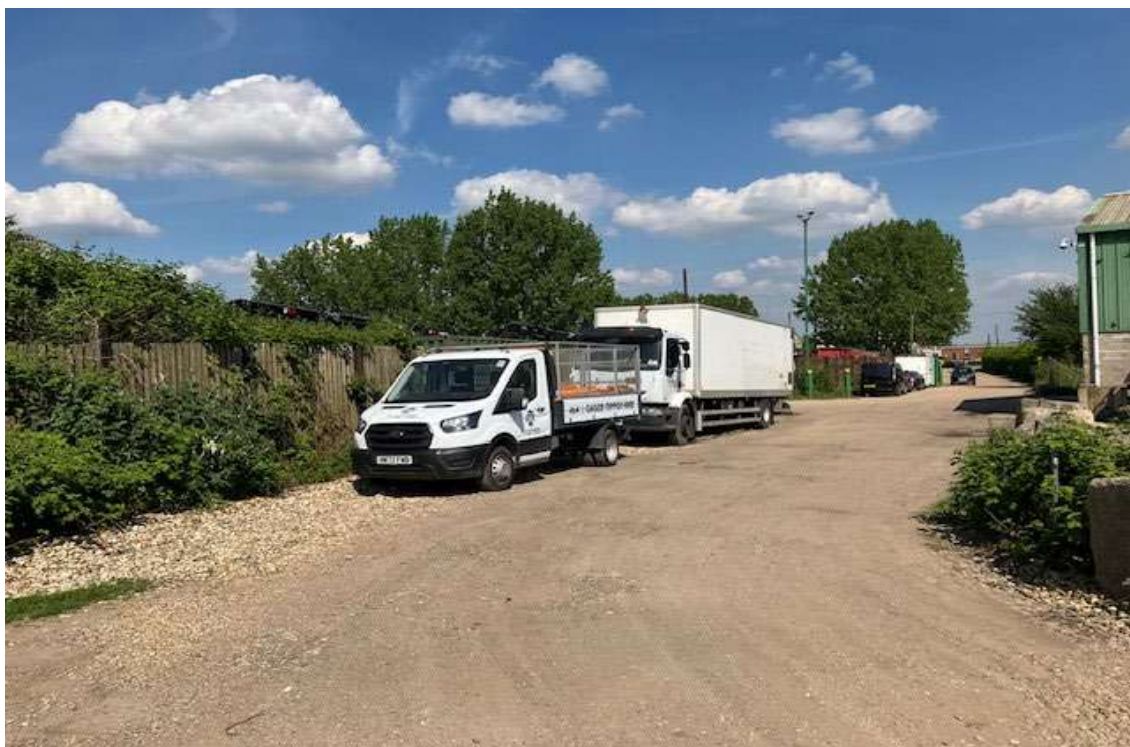
Plate 4: Manor Farm - Data Centre Site (southern extent looking East from south-west corner)

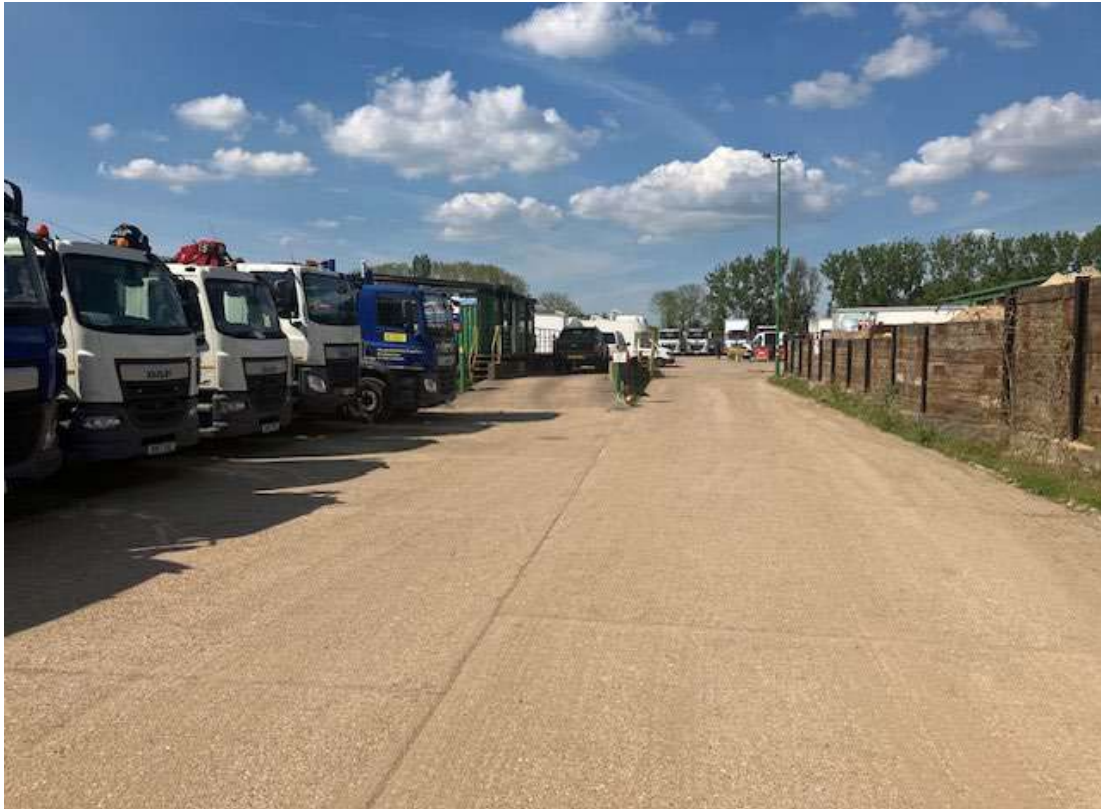
Plate 7: Manor Farm – Data Centre Site Interior View (looking north from southern access road)

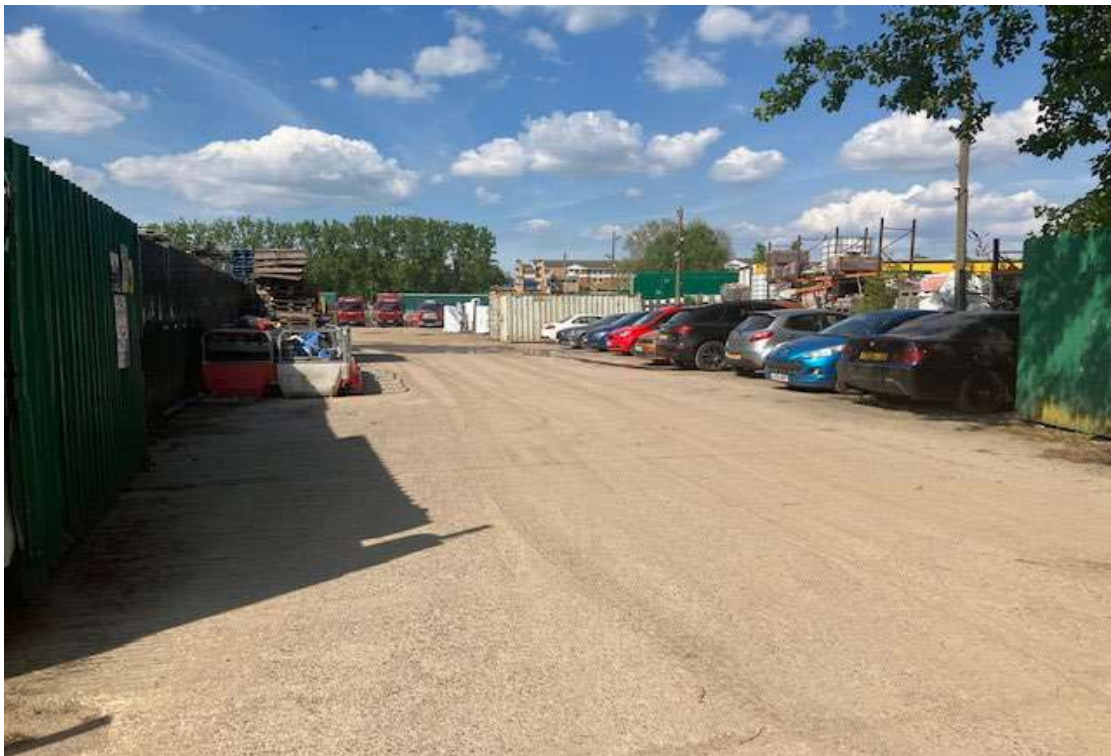
Plate 8: Manor Farm – Data Centre Site Interior View (looking north from southern access road)

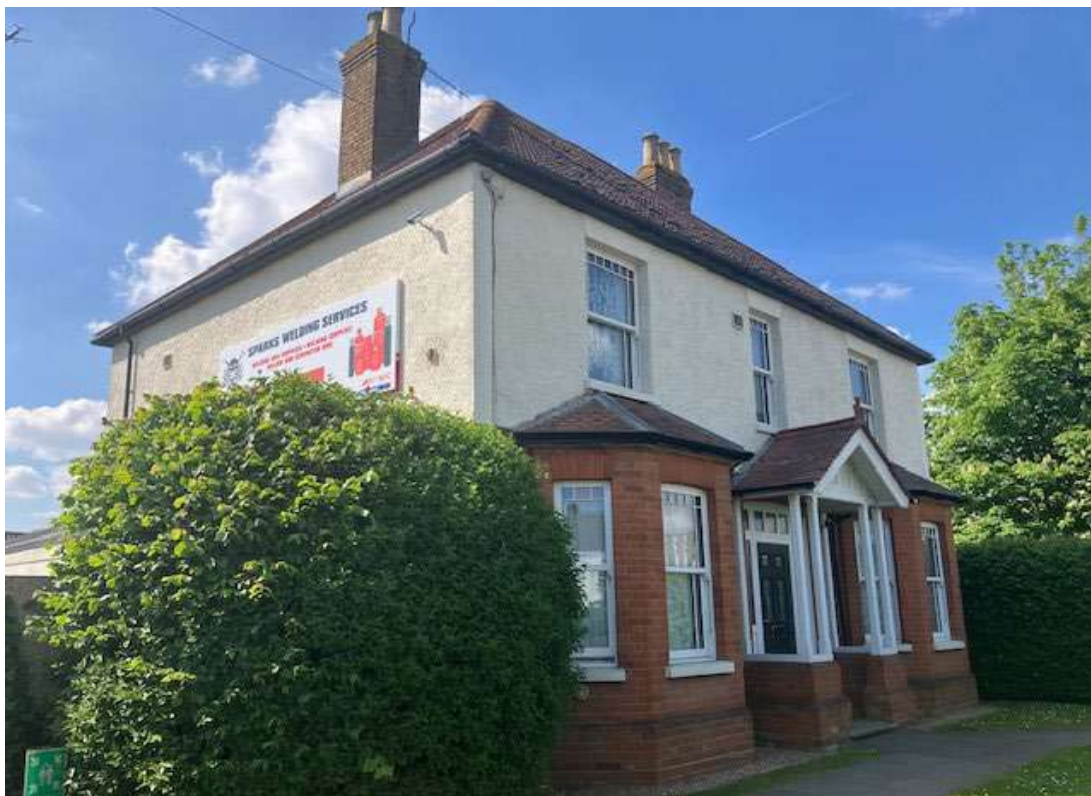
Plate 11: Building at Manor Farm (SHER 21877)

- 4.105 By the 1923 1:10,560 scale Ordnance Survey Map (Fig. 12) is the first to show 'Manor Farm' as three buildings on the north side of the east-west access road. two of these remain (see Plates 11 and 12). A small orchard is shown to the north side of these buildings but the site is otherwise open. There are no

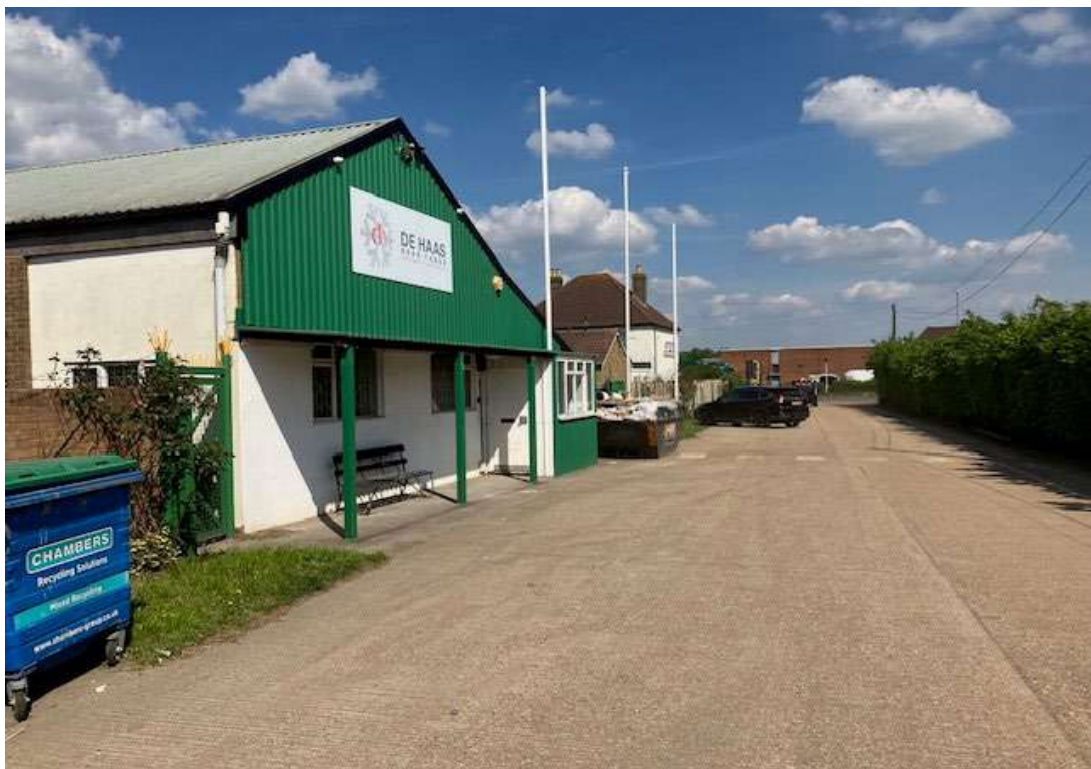
Plate 12: View north-east-east of former Manor Farm buildings
