Manor Farm Cables: Laleham Substation Corridor, Biodiversity Net Gain  
Assessment

MANOR FARM CABLES:  
LALEHAM SUBSTATION CORRIDOR

UK HABITAT BASELINE

# River Condition Assessment Report

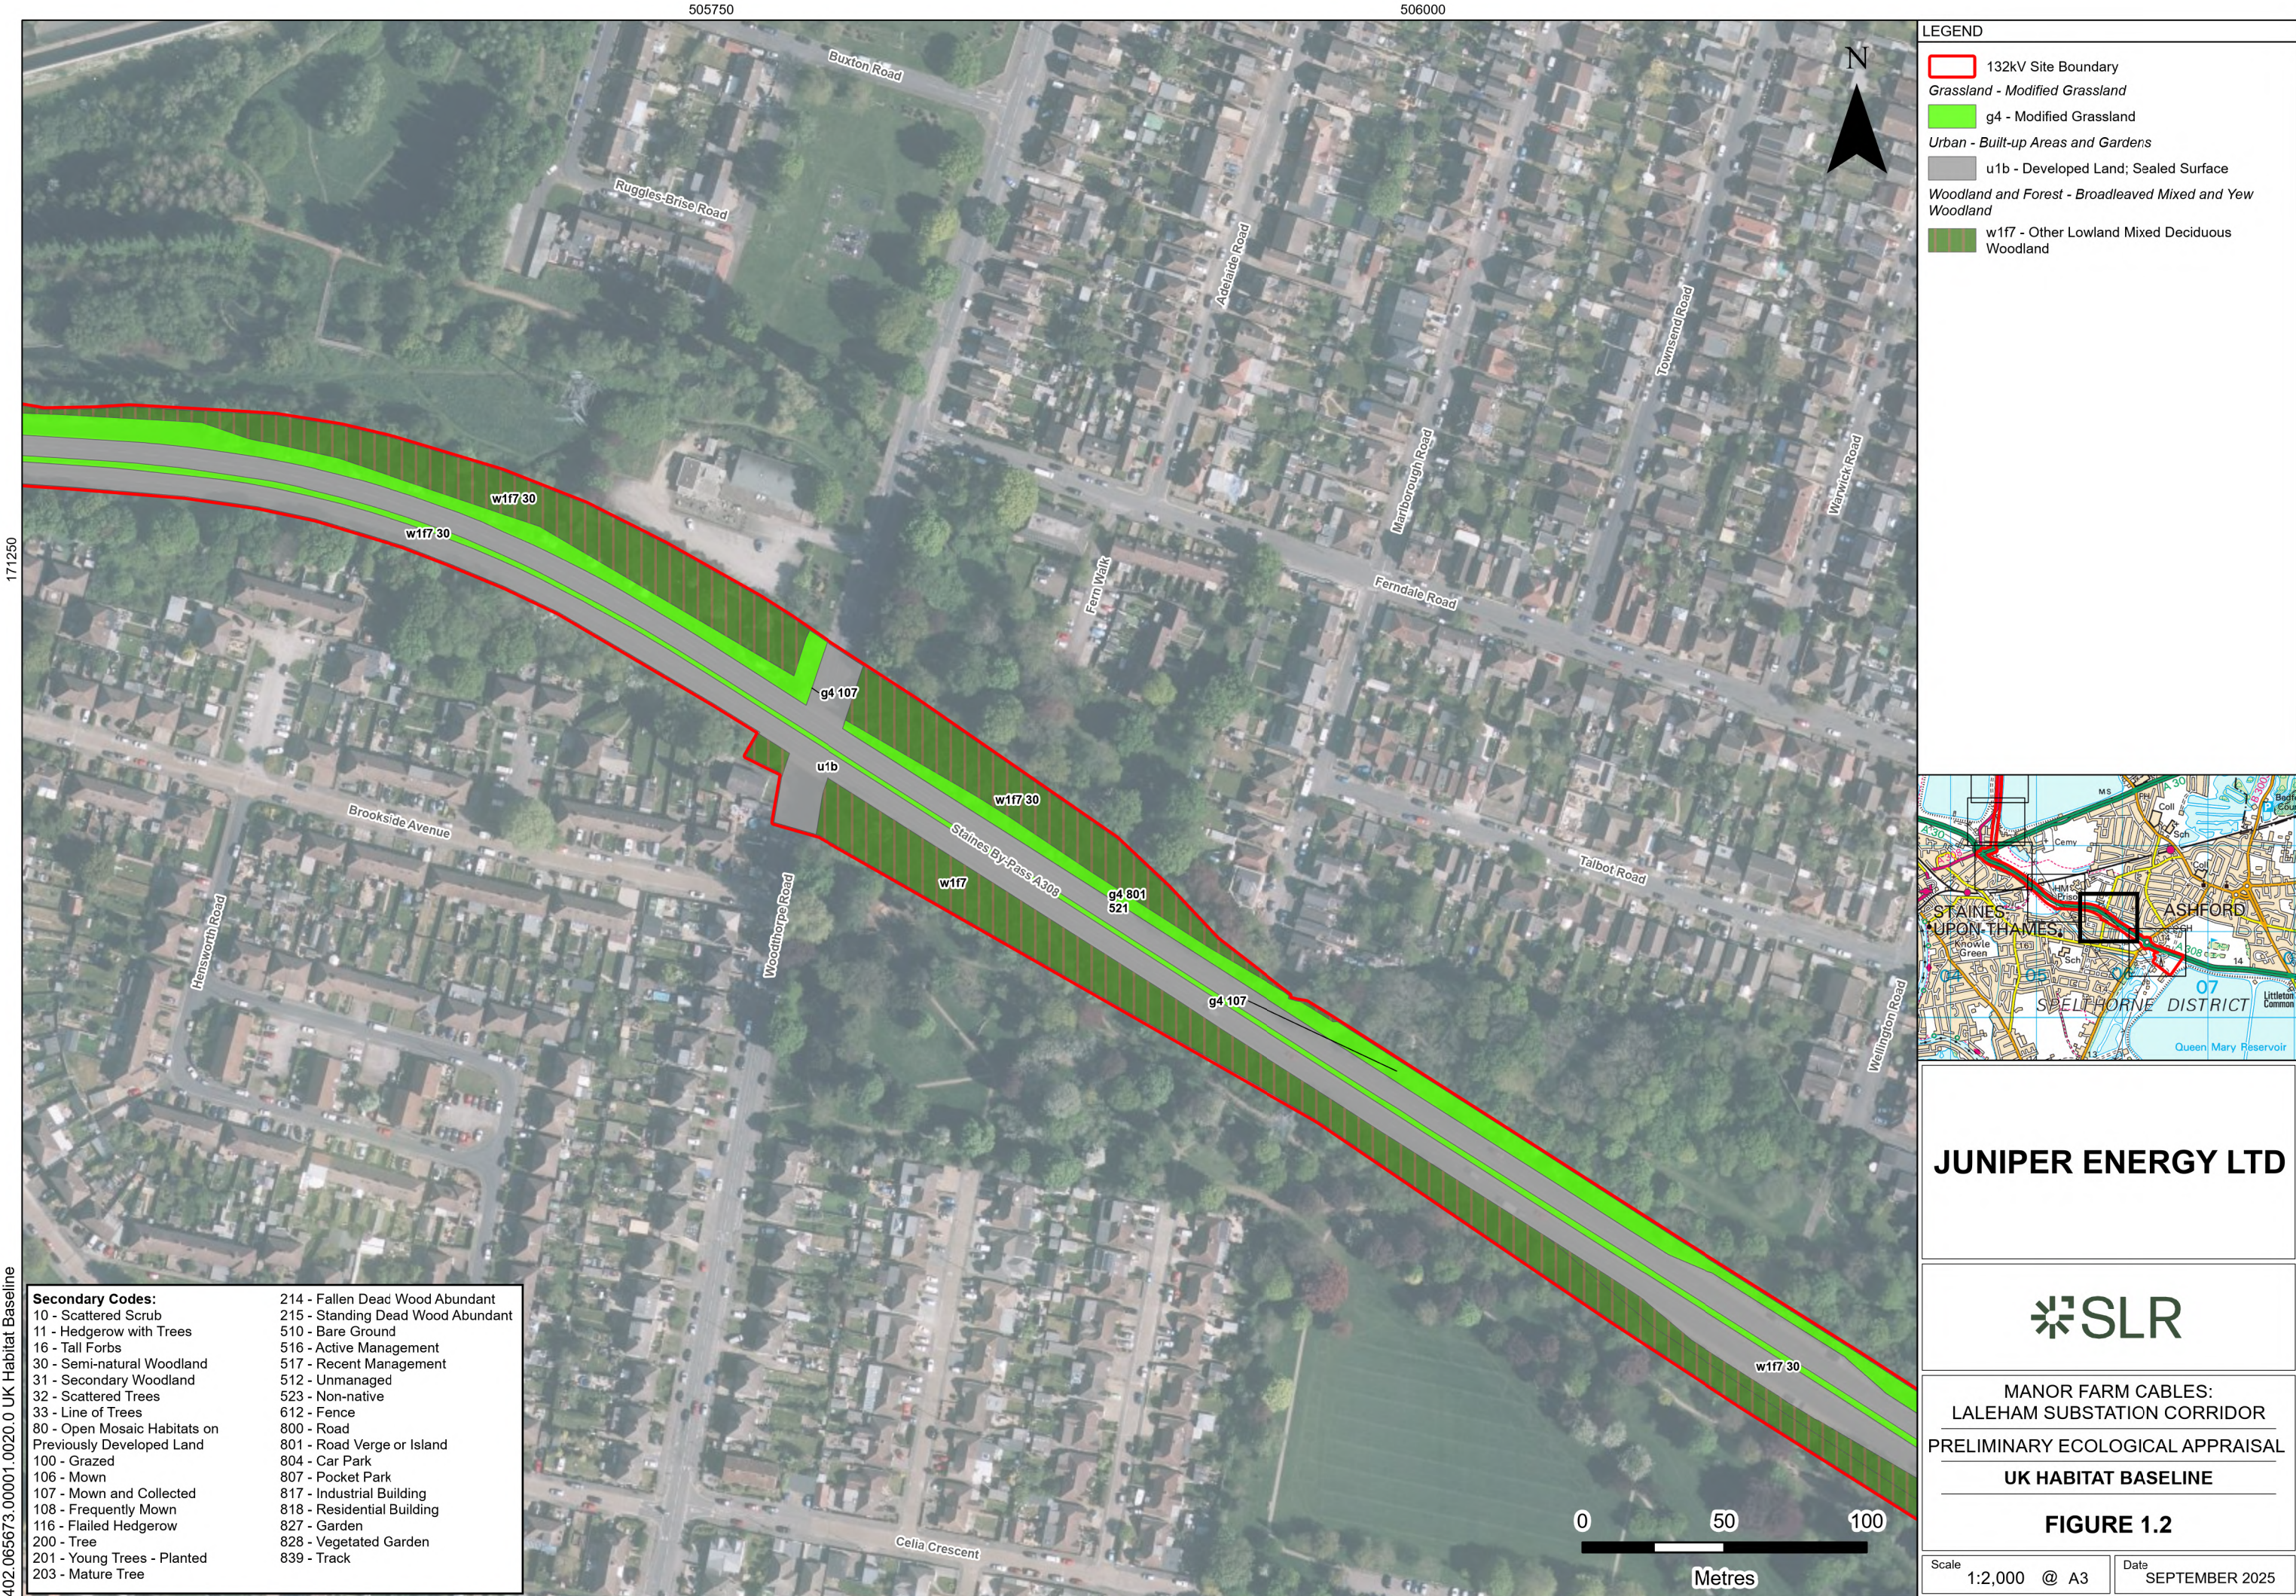
**FIGURE 1.2**

**MANOR FARM CABLES:  
LALEHAM SUBSTATION CORRIDOR  
PRELIMINARY ECOLOGICAL APPRAISAL  
UK HABITAT BASELINE**

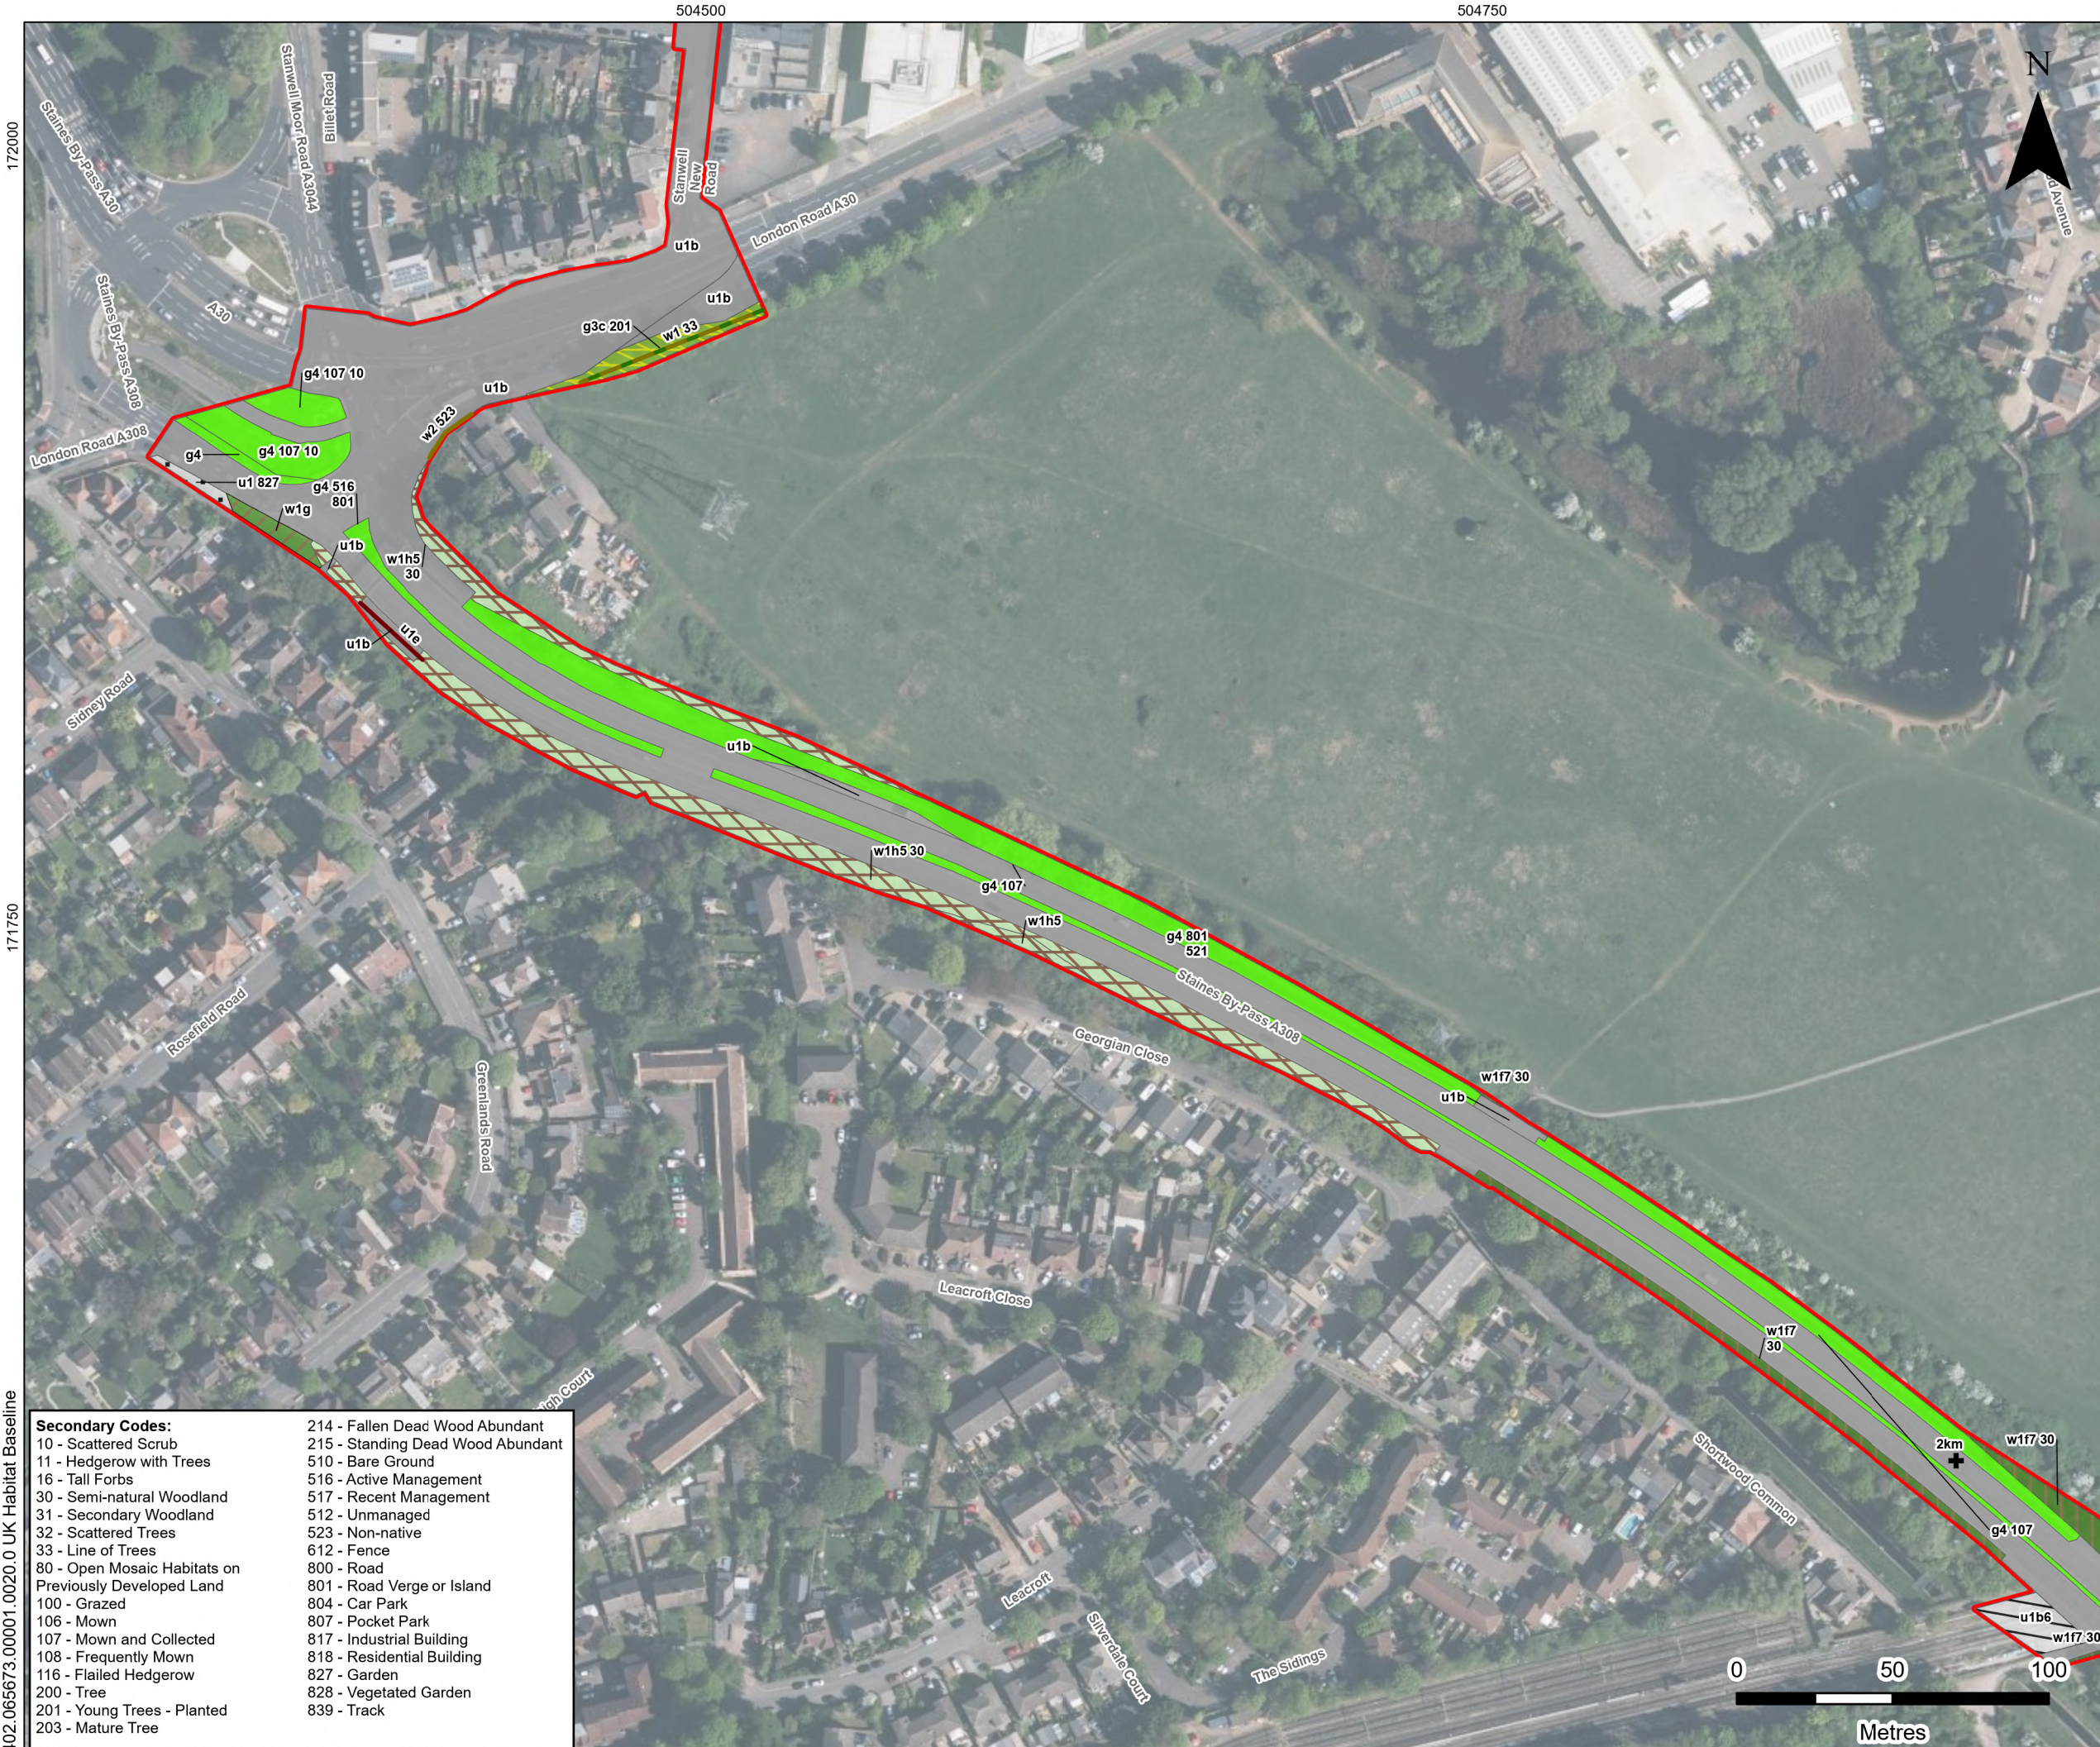
FIGURE 1.4

UK HABITAT BASELINE

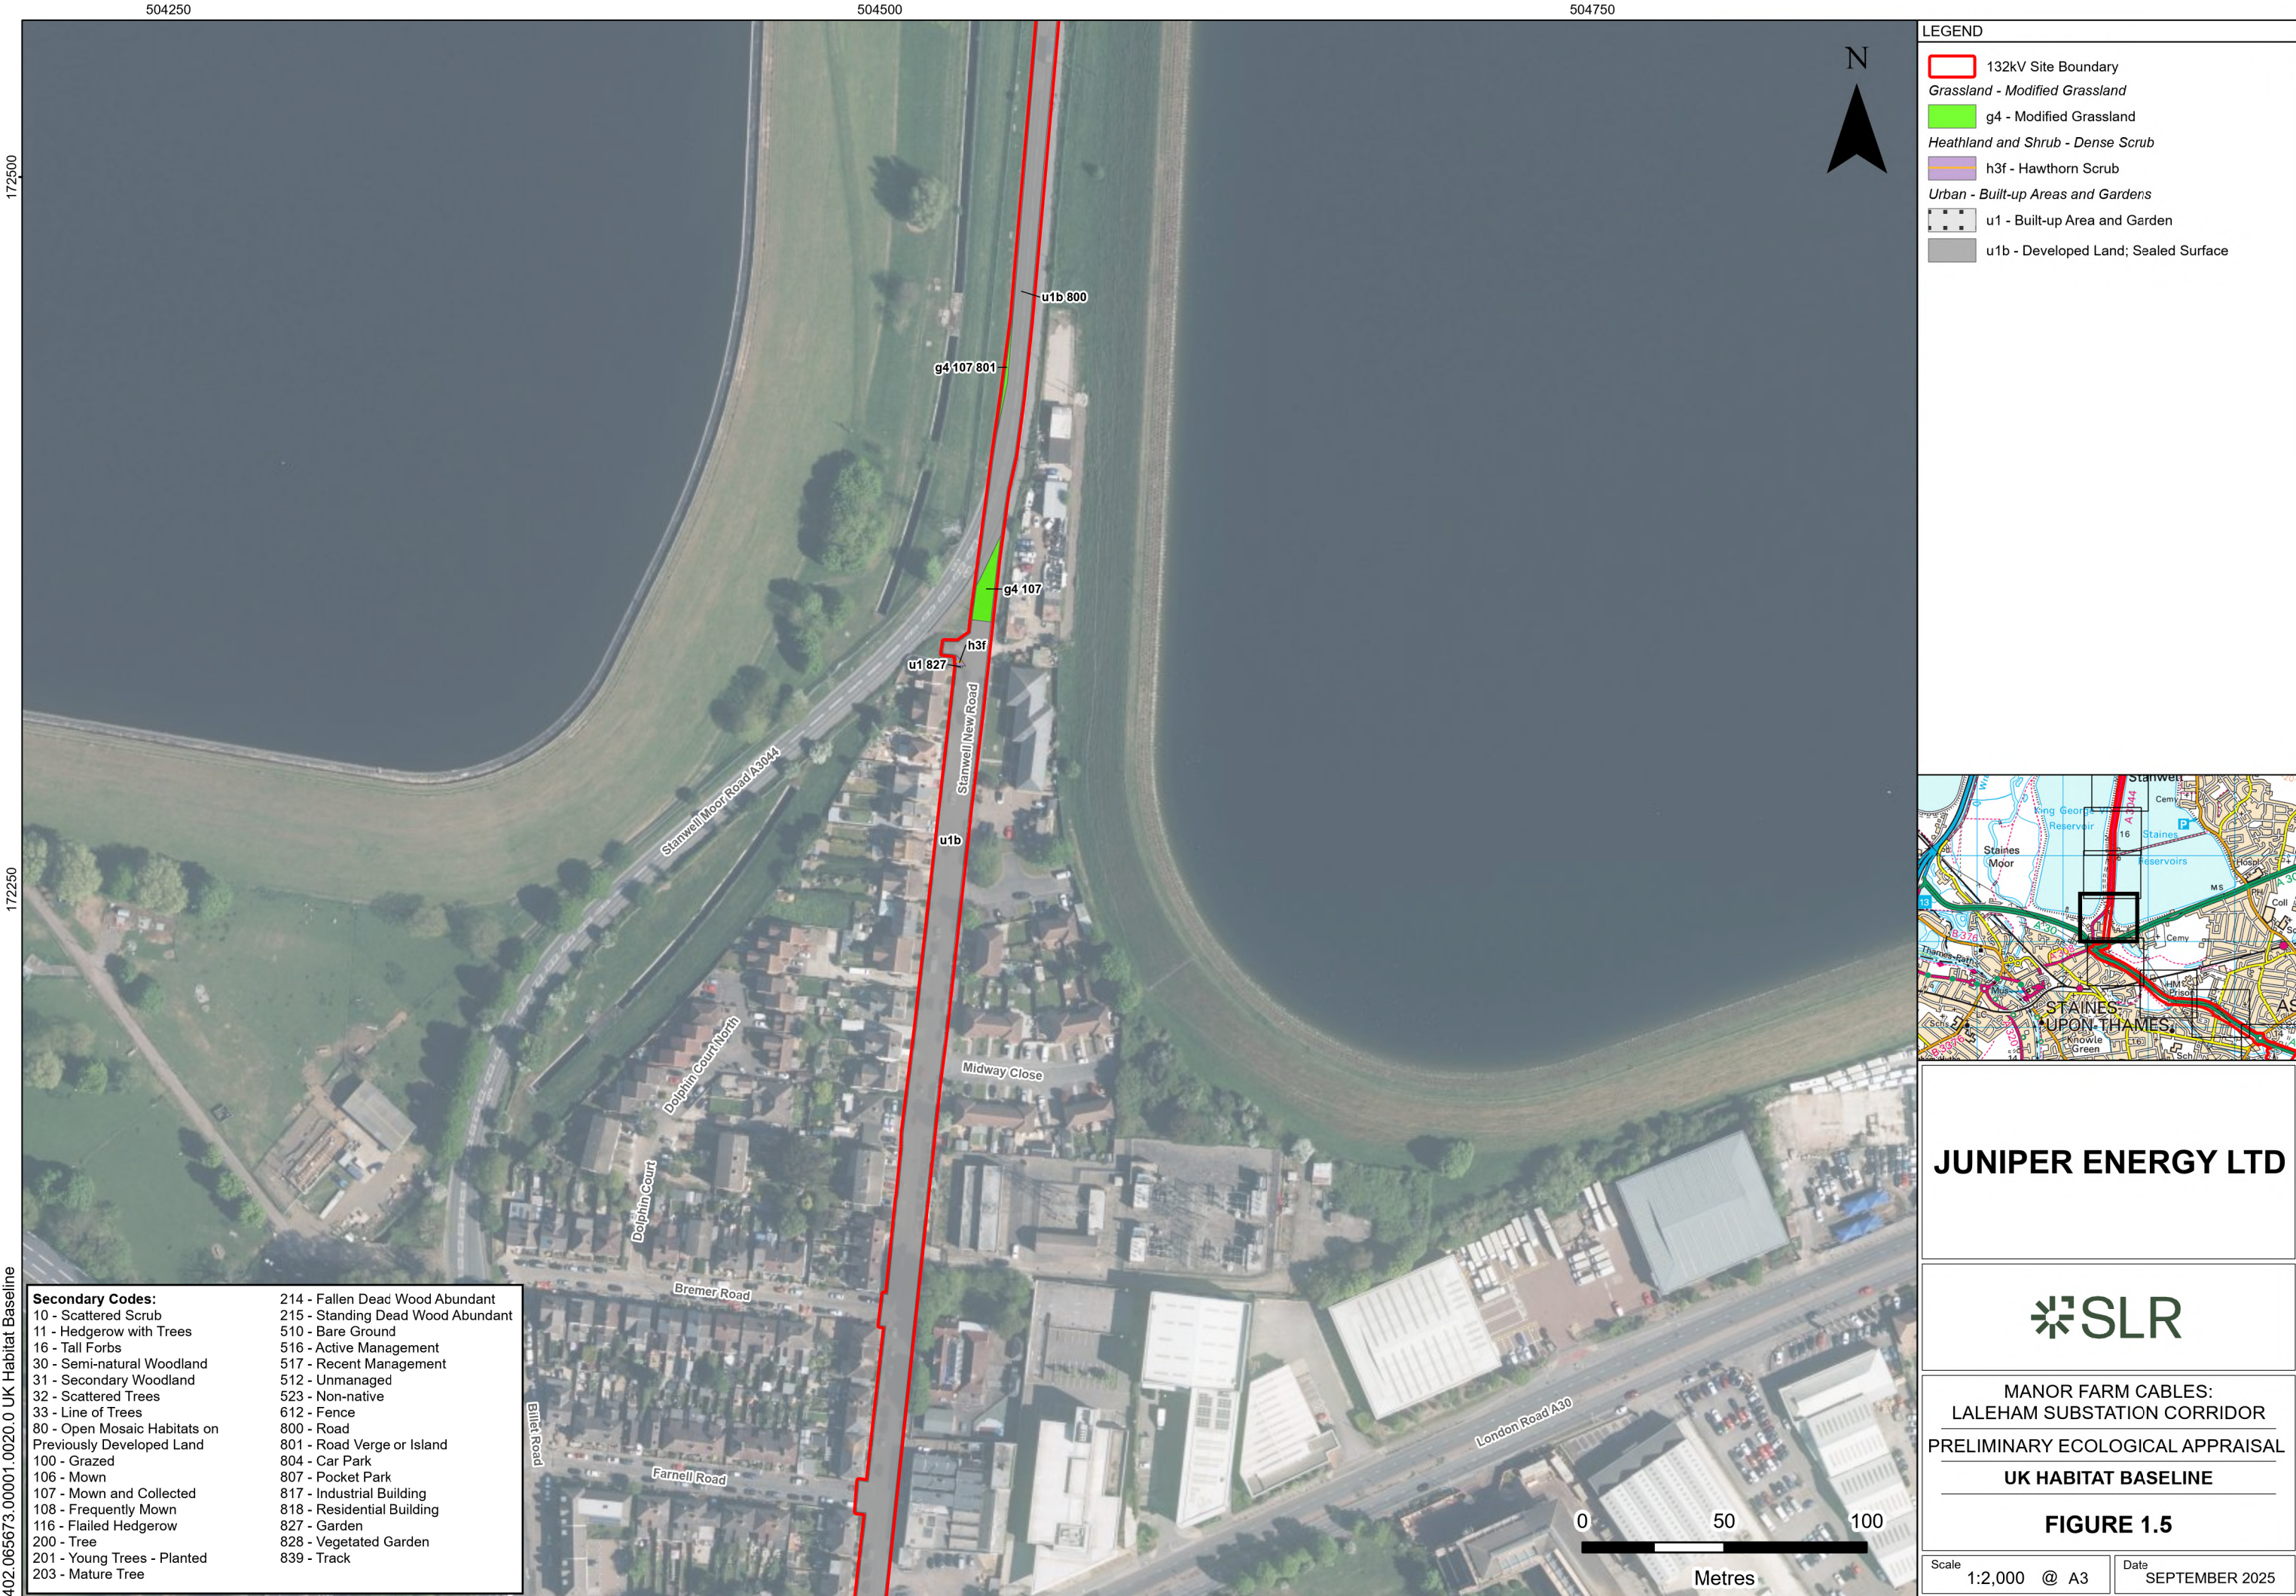
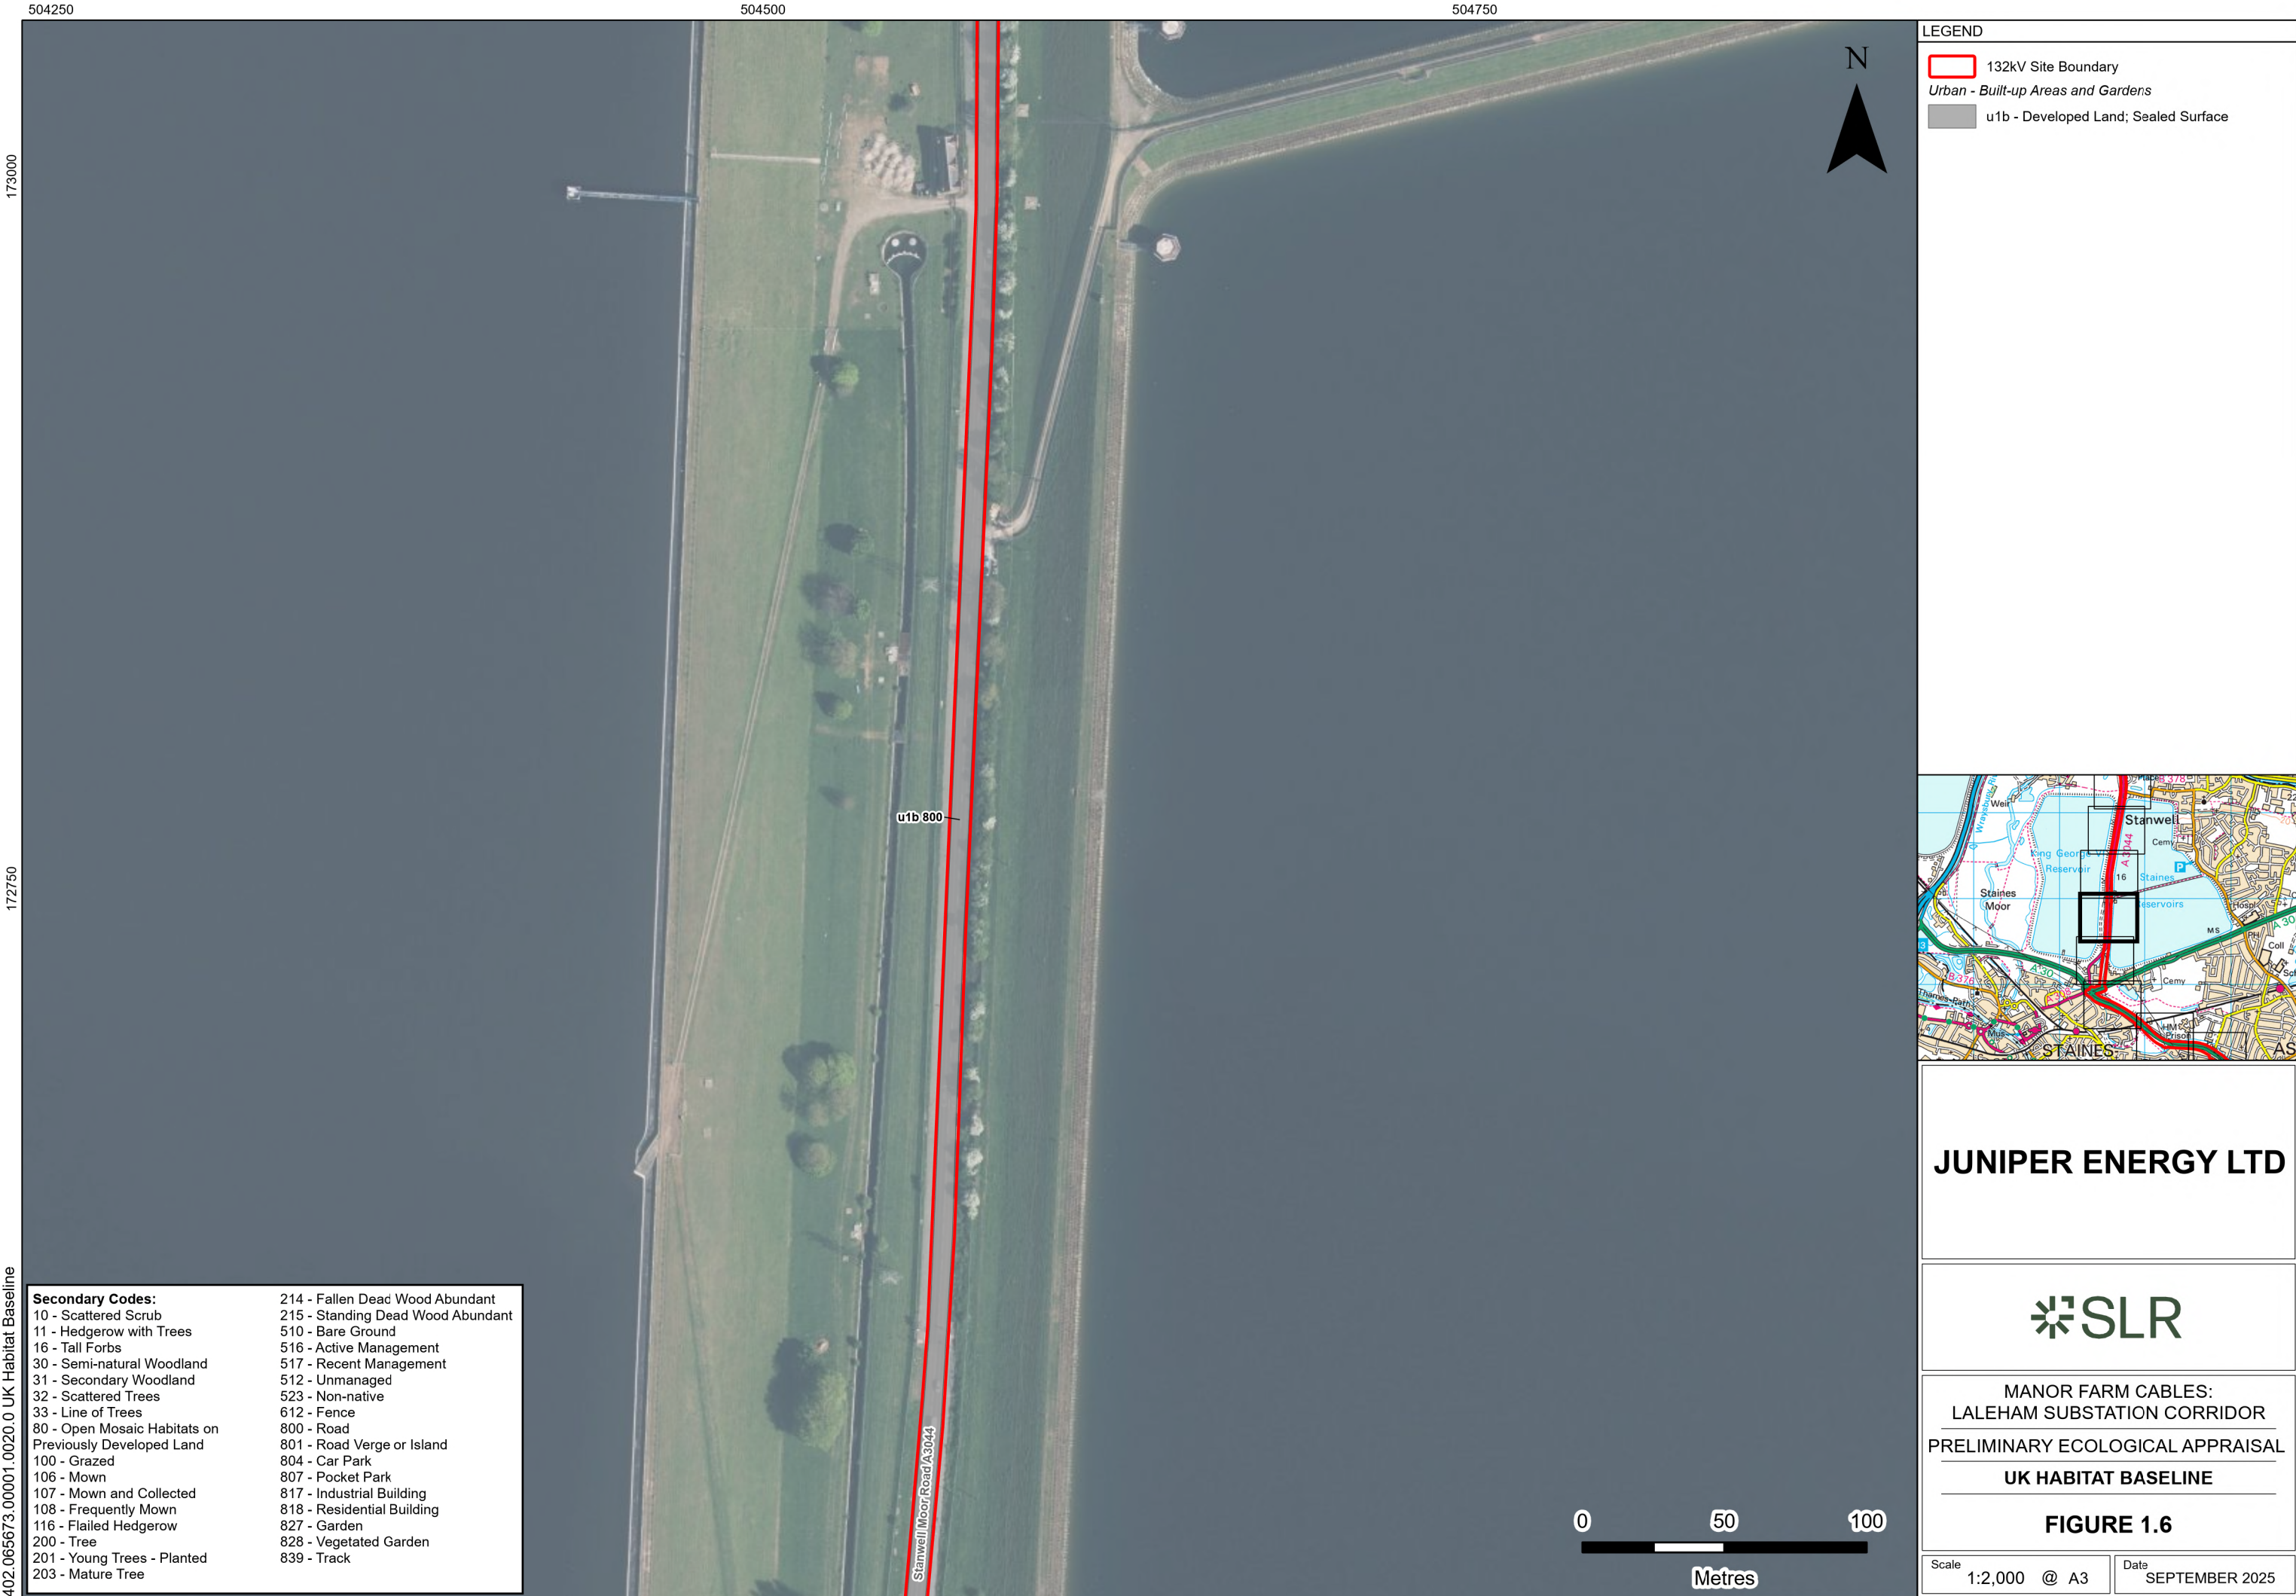
FIGURE 1.6

MANOR FARM CABLES:  
LALEHAM SUBSTATION CORRIDOR  
PRELIMINARY ECOLOGICAL APPRAISAL  
UK HABITAT BASELINE
