River Condition Assessment Report

Manor Farm Cables: Laleham Substation Corridor

Juniper Energy Limited

SLR Project No.: 402.065673.00001

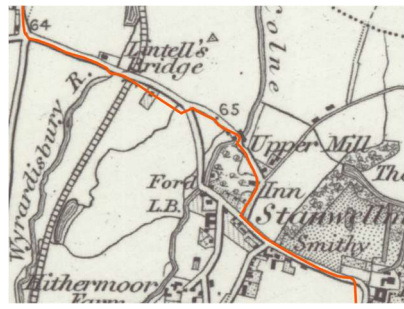
Date	Description	Map Excerpt
1885 to 1903	A smithy is reported within the Stanwell Moor. A mill is located to the west of Stanwell Moor along the road followed by the CR. The CR passes over a set of railway lines running between Colnbrook Station (north) and Staines Station (south). The River Colne and Wraysbury River alongside other watercourses are also observed to be crossing the CR.

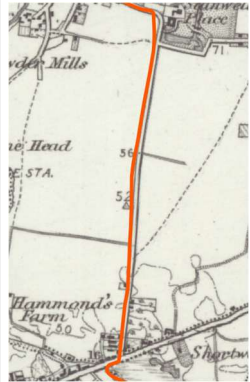
Date	Description	Map Excerpt
1885 to 1903	Minimal residential dwellings are located around this section of the CR. A small pond is located to the east of London Road. The route follows the road, with open agricultural land and small tracks on either side. The village of Stanwell is located c. 900m to the east of this CR section end point. The end of this section is reported to be surrounded by Stanwell Moor, with a few scattered dwellings and structures

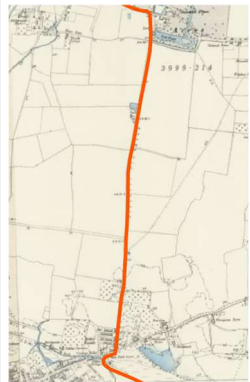
1888 to 1913	A fishpond is recorded to the east of the CR and south of Stanwell Moor. A small gravel pit and pond are recorded to the west of Staines Moor Road. A river 'Crooked Billet' is recorded crossing the CR at London Road. The 'Billet Estate' is located at the southernmost point of this section of the CR.

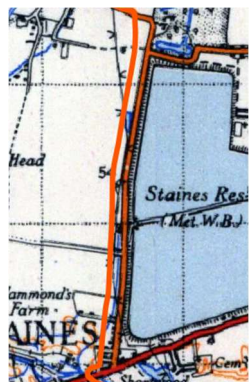
1919 to 1947	The Staines Reservoirs have been constructed to the west of the CR (constructed date 1902). The Staines Aqueducts are now visible within the historical mapping, with a pumping station to the west of the bottom of this section.

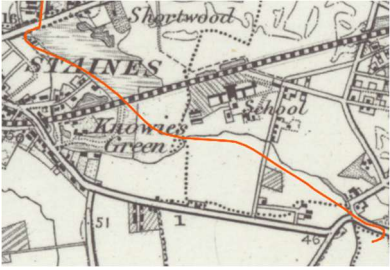
Date	Description	Map Excerpt
1885 to 1903	<p>The site of Laleham substation and the surrounding area is shown to comprise undeveloped land and woodland. A public footpath is recorded along the north and west boundaries with a road also orientated east west along to the north. The River Ash is detailed to cross the CR at two points.</p> <p>The CR is characterised by open agricultural land occasionally crossing footpaths, small roads. A unnamed river is noted to the east of Staines boundary. The village of Staines is located to southeast of the CR. Railway lines between Staines (southwest) and Feltham (northeast) cross the CR.</p>

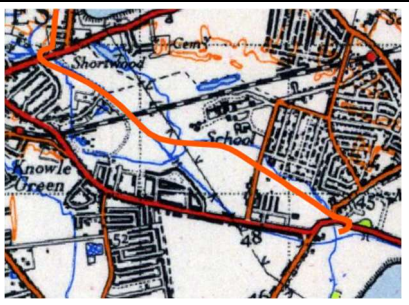
1919 to 1947	The Queens Mary Reservoir has been developed. Ashford and Staines have expanded. The Staines Aqueduct is now recorded to the south of the CR.

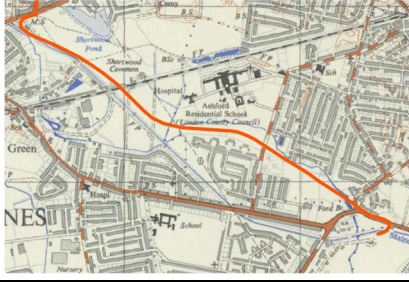
1937 to 1961	Ashford and Staines are recorded to have undergone further expansion with the two towns beginning to merge.
